# Initiation Identification in Fused Silica 355-nm Optics

*M. Wall, J. Plitzko, M.J. Fluss*

This article was submitted to  
XXXIII Annual Symposium on Optical Materials for High Power  
Lasers, Boulder, CO, October 1-3, 2001

**January 4, 2002**

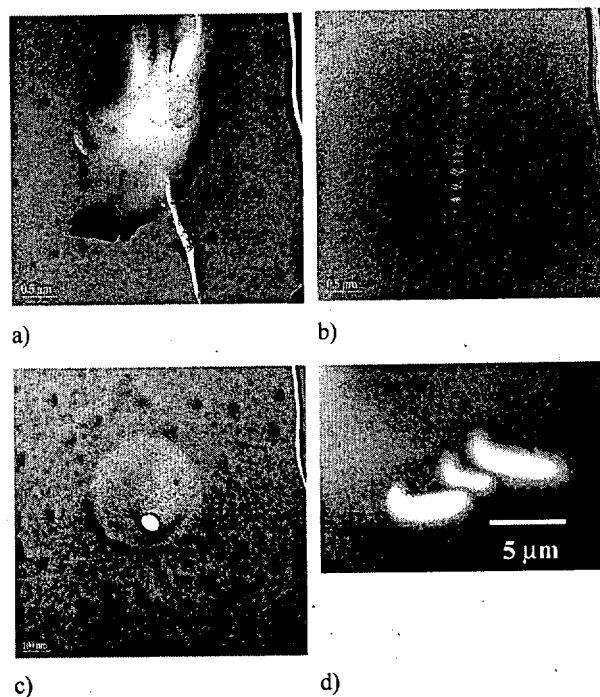
The observed near-surface or surface irregularities can be sub-divided into three groups: mechanical indents, pits and smooth surface depressions. Figure 1 illustrates these three types of observed near-surface irregularities seen in planview TEM specimens. In Figure 1a, a mechanical looking divot is shown. The bright regions within the central part of the divot is the shallow portion and the darker annular region is where there is either a thicker brim around the divot protruding up from the polished surface and/or the region is a more dense form of  $\text{SiO}_2$ . Energy filtered imaging thickness maps of several divots show that they are quite shallow, 10nm to 50nm deep. These divots often ( $\approx 20\%$ ) had cracks (median structures perpendicular to the optical surface) associated with them. All of the cracks seen are very narrow ( $< 50\text{nm}$ ) and range in lengths from 10nm to  $10\mu\text{m}$ . The depth measurement of the cracks was sometimes less than the thickness of the sample (i.e.  $\approx 100\text{nm}$ ) and sometimes greater than the thickness of the specimen. Hence, some cracks are truncated by the finite thickness of the specimen. Often the divots have one or more divots near by that are similar in morphology but not as deep. Chemical analyses of these divot regions do not show any specific chemistry associated with them. The cracks all appear to be empty. In Figure 1b a linear row of smaller divots are seen. We call this micro-chatter. Typically these do not have densified or thicker annular regions around any one divot. The chemistry associated with these chatter marks is also not abnormal, and there does not appear to be any cracks associated with these chatter marks. In Figure 1c we observed a pit that goes through the specimen. Stereo analysis confirms this. In Figure 1d we see shallow surface depressions that are very smooth looking, unlike the divots in Figure 3a. There does not appear to be cracks or unusual chemistry associated with these surface depressions. The total number of defects seen by planview TEM in 4 samples was  $\approx 65$ . Approximately 75 % of the defects were of the mechanical nature as in figures 1a and 1b, with  $\approx 20\%$  of these having cracks associated with them. Approximately 15% of the defects were pits as in Figure 1c and the remainder being defects seen in Figure 1d. In all, the total area sampled by planview TEM was  $\approx 400\mu\text{m}^2$ , thus the population of these defects is  $\approx 2.5 \times 10^5 / \text{mm}^2$ .

**Figure 1:** Mechanical damage observed in polished and acid etched fused silica specimens. a) densified "divot-site" with accompanying median crack; b) an example of what we call micro chatter consisting of a series of "divot-sites" similar to those seen in panel d); c) small isolated divot or "dig" which passes through the 100nm specimen; d) chatter marks without cracks.

Cracks, particularly median cracks, such as those observed in this work are a consequence of the balance between productivity and perfection in the polishing of fused silica optics. Can such cracks be initiation sites in themselves? As shown in recent results of Genin and co-workers [8] and Hamza and co-workers [7] this is quite possible. Additionally, it is often observed that initiation sites lie along lines or trajectories suggesting a high spatial correlation with some cracks. The open question is, are these mechanical features alone potent initiators or does sufficient energy absorption require impurities as well. Admittedly, the results of [7] are a special case, but it is demonstrated that cracks arising from slow scratches are sufficient alone to act as initiation sites in a range of fluences of technological relevance. The present TEM results strongly suggest that this question deserves further modeling and experimental investigation. As additional empirical evidence for the

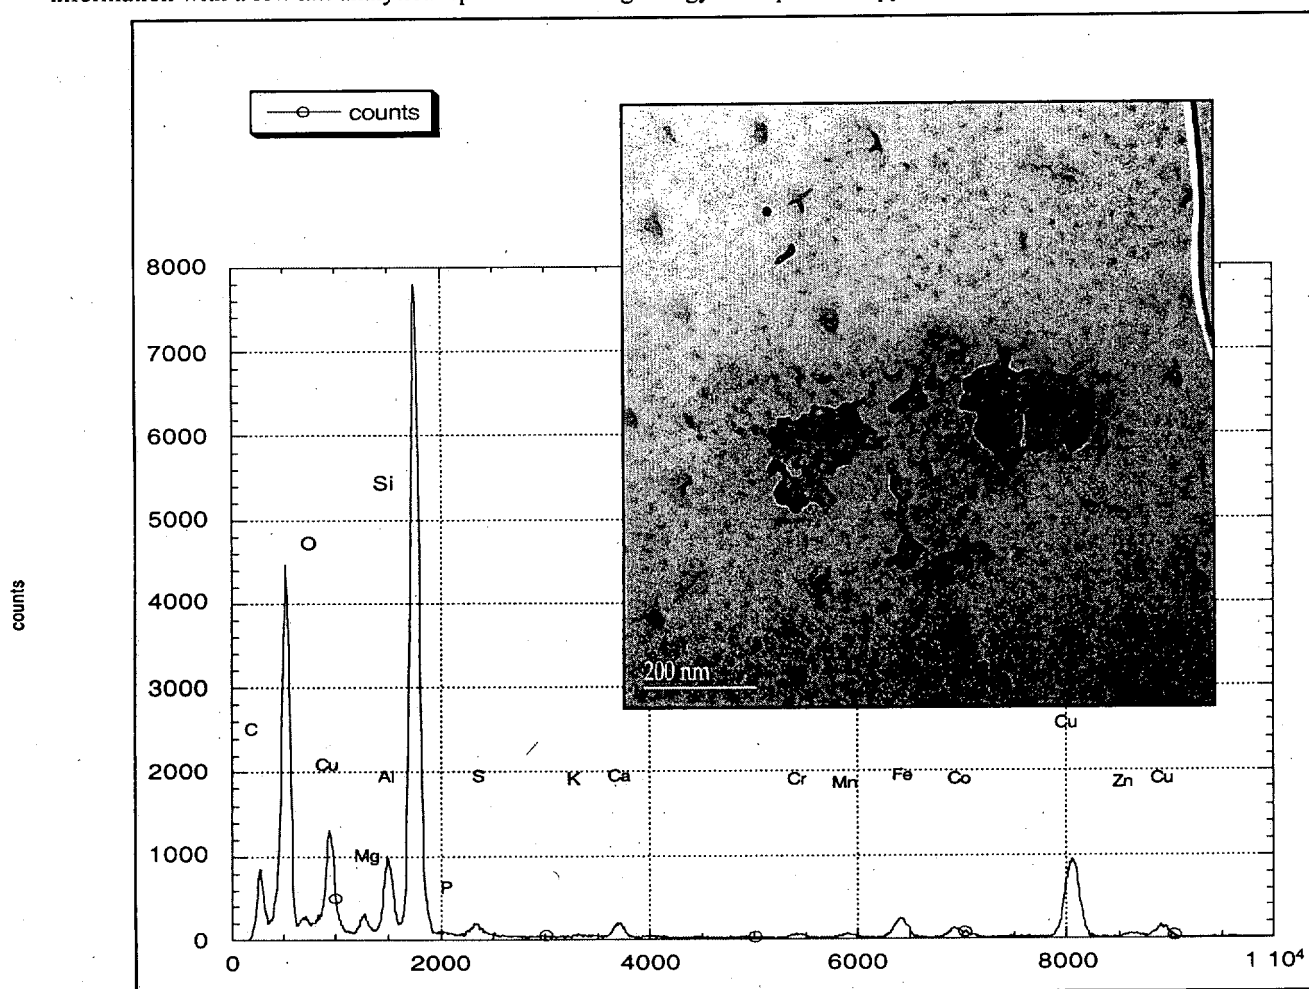
In all of the planview specimens, there was high density of surface debris. Most of this was probably from the Modalac. Stereo pair analysis confirmed that this debris was on the surface. We also observed a region of microstructure other than amorphous  $\text{SiO}_2$  where stereo analysis showed that there was particulate *within* the  $\text{SiO}_2$  specimen. Figure 2a is an image of this structure. Energy filtered TEM showed that the amorphous component contained carbon. In addition, energy dispersive spectroscopy (EDS) analysis (shown in Figure 2b) for this area showed that there were other elements present. Additional elements detected included; Cu (as a resolvable 100nm particle with enough Zn present to possibly be brass), Ca, Mg and Al. Electron diffraction showed that there was some crystalline component to this structure but we were not able to index the spots to any particular phase. The *Analytical Phillips 300 KeV FEG* (field emission gun) transmission electron microscope (TEM) is both a powerful near atomic resolution imaging tool, and an analytical instrument capable of providing chemical information with a few nm analytical spot size utilizing energy loss spectroscopy.

**Figure 2:** a) (top) TEM micrograph of a near surface included particle. b) (bottom) EDX spectrum (counts vs eV) from the area of the inclusion showing the presence of carbon and copper.

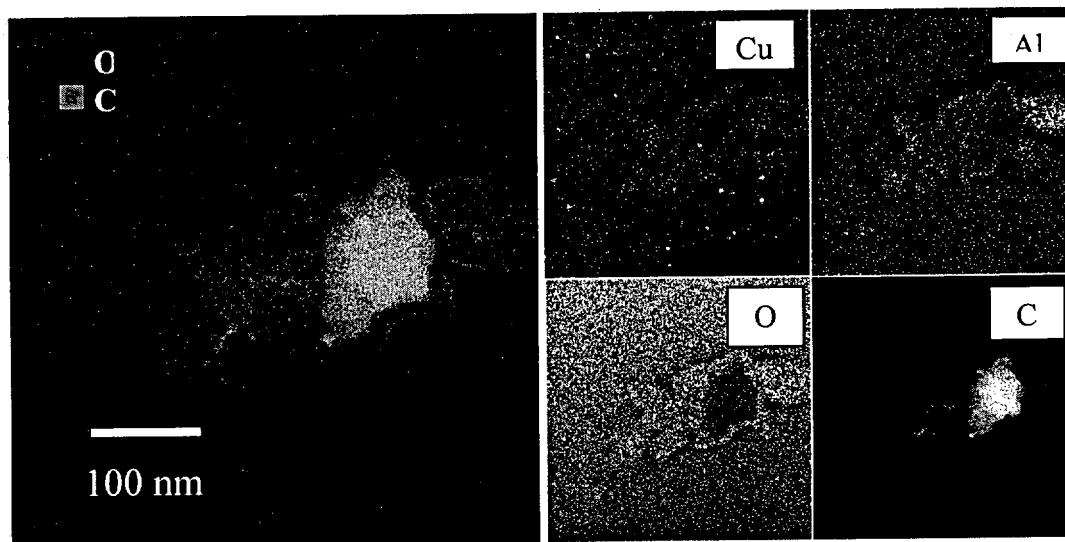
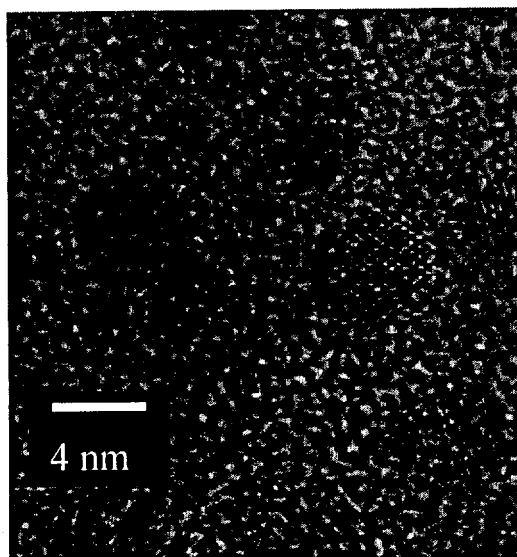
Having observed particulate with EDS and TEM that was imbedded within the near surface of our fused-silica specimens we set out to search more carefully and to characterize in more detail any other particles that we could discover. Figure 3 is typical of what we saw. We observed a quite complex particle made up of several morphologies and several elements. There is a carbon rich region that is depleted in oxygen, which on further analytical analysis suggests that its diamond or diamond-like material. The same particle is also rich, in some areas, with aluminum, but here there is a correlation with oxygen suggesting alumina. Finally, there is clear evidenced for a population of ~5nm diameter particles that are Cu rich. Atomic resolution imaging shows that these particles are indeed crystalline since their atomic columns could be imaged for some

fortuitous orientations. The particles observed here were proven, using several TEM analytical techniques including stereomicroscopy and energy loss methods, to be below the surface of the finished optic. It is worth noting that our attempts to observe such particulate (in the bulk-region well below the surface yielded negative results, consistent with the results from cross-sectional specimens studied earlier.

**Figure 3:** In these micrographs we have visualized a complex particle imbedded in the near surface region of the fused-silica. The Phillips FEG TEM makes available extensive chemical characterization and near atomic resolution. The upper pictures (large and four smaller replicas) illustrates a carbon based particle (~80nm diameter surrounded by an oxygen rich matrix. Additionally, there is evidence for Al ( $\text{Al}_2\text{O}_3$ ) and many small copper particles. The lower micrograph shows us that the nm-size copper (possibly copper alloy) particles are indeed crystalline by revealing columns of atoms in those nano-grains oriented appropriately to the electron beam of the TEM.

For the fused silica specimens studied here particulates are a significant feature. Thermo-mechanical calculations show that temperatures high enough to cause damage are only likely if the contaminant was present as particles with diameters of >10nm (4, 9). The sizes of the carbon (likely diamond) and copper alloys (brass) particles are, in some cases, sufficiently large to be potent initiators. Pure diamond would also be expected to be transparent at 355nm. However, industrial diamonds that would have been used in the grinding phase of manufacturing would not be. The origin of the copper is likely from the same grinding process, as most grinding wheels or pads are manufactured with a brass substrate embedded with diamond grit. A possible scenario for the origin of the aluminum may be associated with the extensive use of colloidal alumina. Even here, although alumina should be transparent at 355nm, industrial grade material appears to absorb energy due to chemical impurities common in its production.
